**Professional Analysis
and Consulting, Inc.**

Project No. 2017

Brittany B. Hilton

SIG SAUER, Inc.

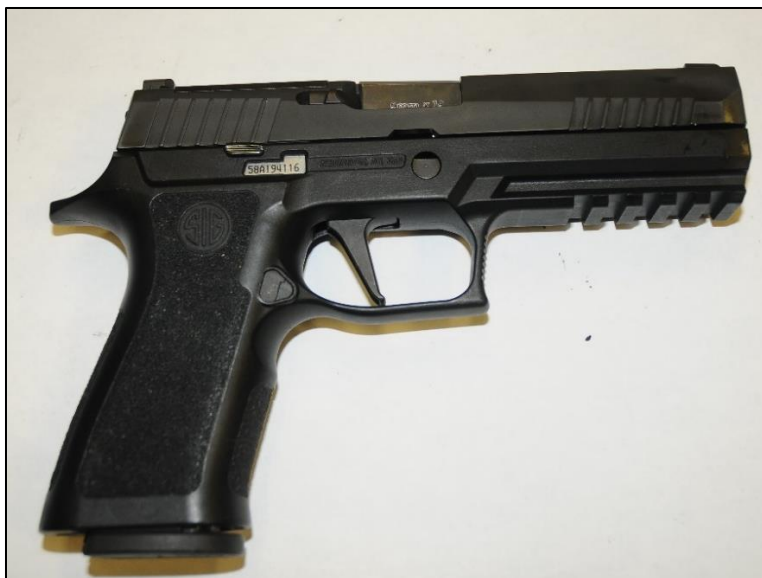
During the July 14, 2022, inspection, the subject P320 X Carry 9mm was verified as having Serial No. 58A194116. This was an upgraded version of the P320 and was otherwise in as-produced condition, except for normal and anticipated wear since Detective Hilton utilized the subject firearm as her service weapon. Detective Hilton had significant qualification and training practice firing the weapon and was familiar with its operation and exercising proper firearm safety. As mentioned, Sig Sauer took possession and disassembled the subject firearm prior to the July 2022 inspection and prepared an inspection report.⁵

Figure 1 - Subject Sig Sauer P320 X Carry 9mm

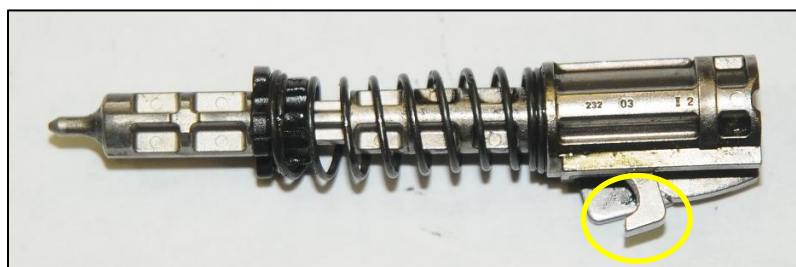
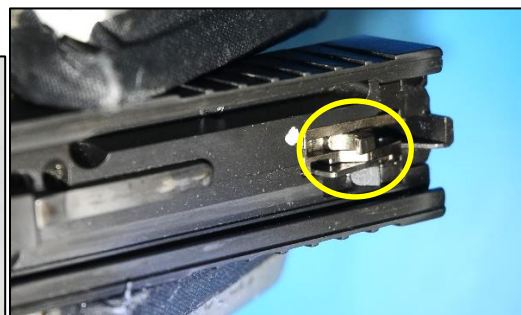
1. The sear and striker pin components, the engagement of which is a critical feature of this design, are produced using a Metal Injection Molding (MIM) process and do not have any secondary machining performed on the small engagement surfaces. MIM produced components can have areas of uncontrolled variability due to the manufacturing process. For surfaces where tight tolerances and consistent fit-up are required, MIM parts will typically have secondary processing, or machining, to eliminate the variation. See Figures 2 – 3.

Figure 2 - Striker assembly with striker foot circled (left), striker assembly in the slide assembly (right)

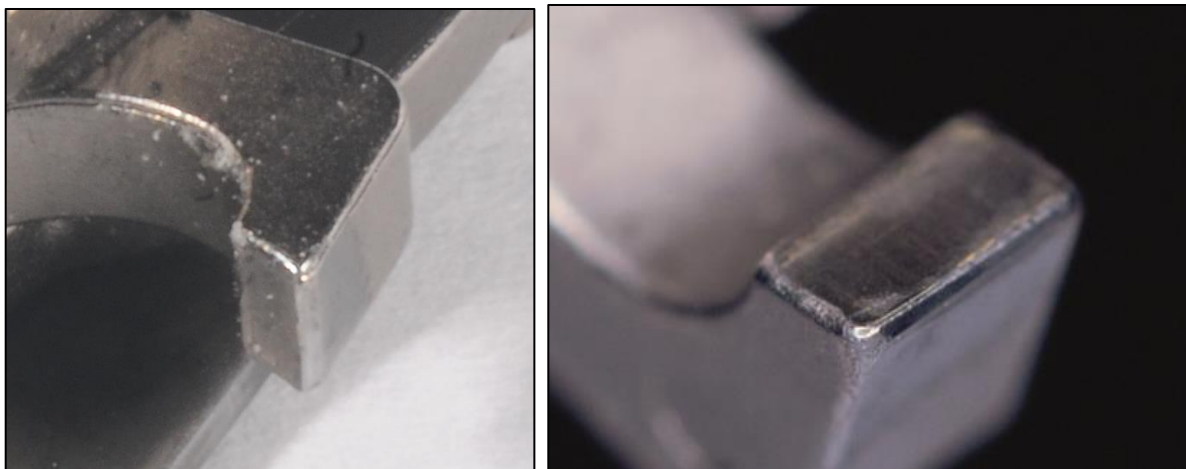
2. The sear and striker foot portion of the striker pin both exhibited inconsistencies on the surfaces that are in contact with each other, minimizing the actual contact surface area that is needed to keep the parts engaged until the trigger is pulled. In addition to the MIM as manufactured surfaces (rough and unmachined), both parts also exhibited a raised area around the periphery of the interface surface. This has been referred to by others as rollover and appears to be a combination of flashing, radiused corners, and shrinkage of the inner surface area. The end result is reduced contact surface area between both components, making the firearm more susceptible to un-commanded discharge. Figure 4 is a close up of the sear step with clear wear marks from the striker foot that shows an inconsistent pattern, including an area within the step with no wear. There is also an inconsistent surface along the top edge of the sear step. Figure 5 has zoomed in photographs of the subject striker foot showing the raised area around the periphery of the face, radiused edges, and an unmachined surface.

Figure 5 – Subject striker foot showing raised outline and unmachined surface

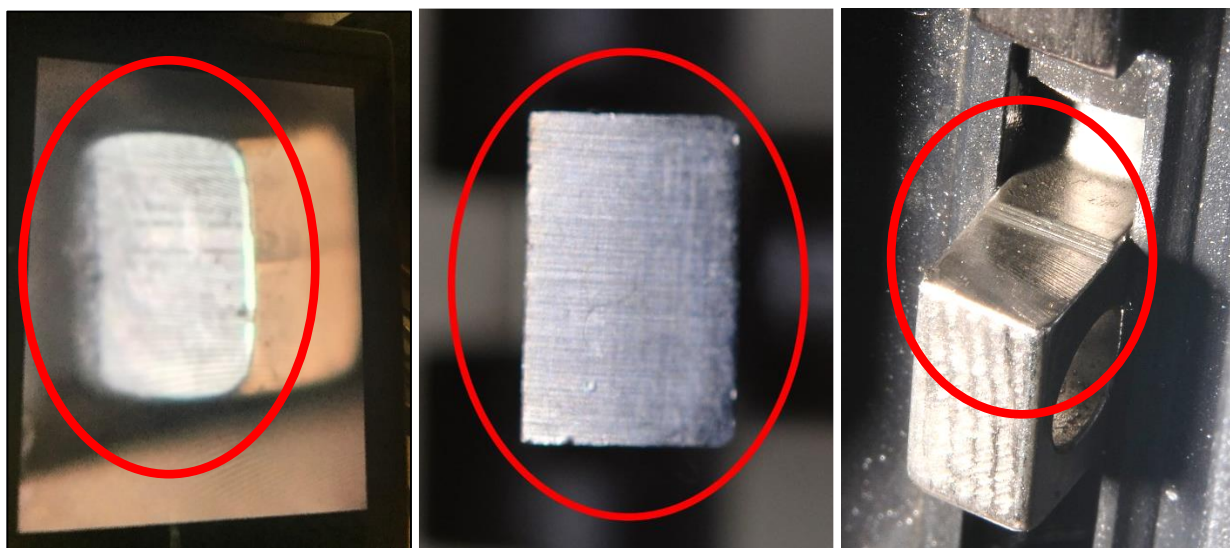
3. In comparison, the photos in Figure 6 show the machined (or some other secondary processing after molding) surface of the striker foot and sear from other manufacturers firearms. As mentioned, the CT scan is unable to be utilized in quantifying or measuring the inconsistencies of the surfaces of the striker foot or the sear step due to its resolution. Feature size and dimensions, including radiused corners, can be measured from CT scan, described more below.

Figure 6 - Other firearms - striker foot (left), and sear face (center), and striker foot (right), all with machined flat surfaces

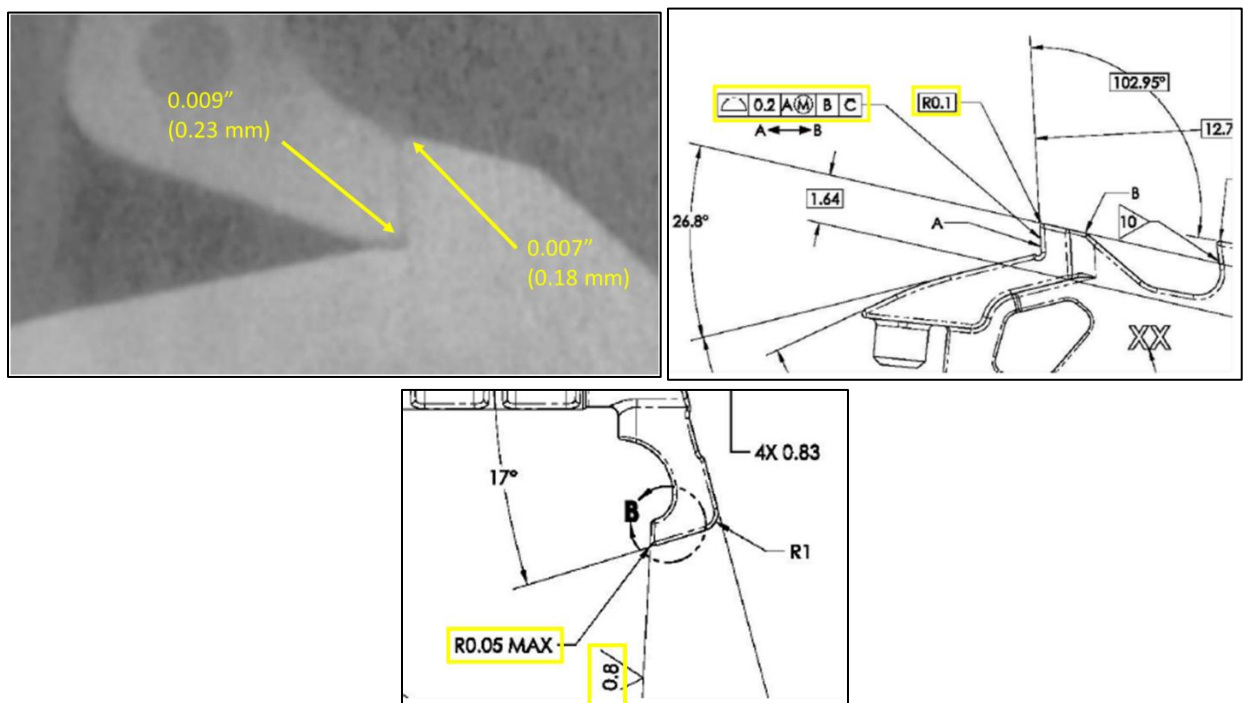
4. A CT scan was also used to document the striker and sear engagement areas as compared to the drawings, shown in Figure 8. The sear step had the top surface, where the striker foot is released from, measured radius at 0.007" (0.18 mm), with the Sig Sauer drawing #1302192⁷ indicating a radius of 0.1 mm. The surface profile where the striker engages indicates a tolerance of 0.2 mm, but as with the other components discussed in this report, this dimension could not be quantified with the CT scan. The CT scan of the bottom edge of the striker foot radius measured at 0.009" (0.23 mm). The Sig Sauer striker drawing #1302193⁸ indicates that the radius on the bottom edge of the striker foot at 0.003" (0.1 mm). This drawing also indicates that the surface that engages with the sear step has a surface finish specification of 0.8, but this could not be quantified with the CT scan.

Figure 8 - CT scan of the subject striker and sear (left), sear drawing (right), and striker drawing (bottom)

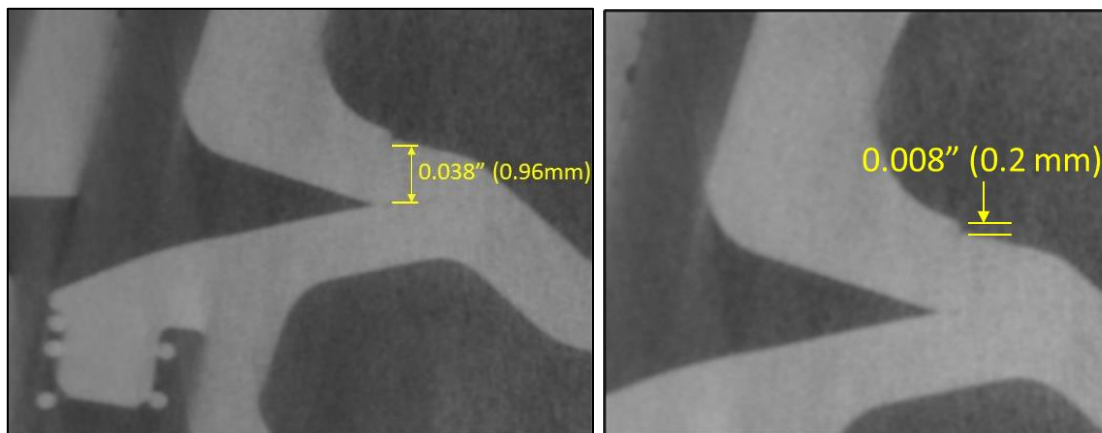
5. In addition to the lack of secondary processing on the sear and striker foot, there is also a vertical misalignment of the two parts, as shown in the CT scan shown in Figure 9. The striker foot is unable to fully engage with the sear face surface, reducing the area available for the engagement of the two parts. With the minimal amount of overlap and engagement between the two components, a minor amount of vibration or relative movement between the slide and the grip module would allow the striker to no longer be retained by the sear, and to move forward and discharge a round. In other words, the ongoing relative movement between the slide and the grip module while secured in a Sig Sauer authorized holster over time will allow the striker foot to become disconnected from the sear face. For reference, the contact surface area measured 0.038" (0.2 mm). No documentation has been provided by Sig Sauer that identified what the design specification is for the contact surface area between the striker foot and the sear.

Figure 9 - Subject striker foot to sear contact surface (left) and vertical offset (right)

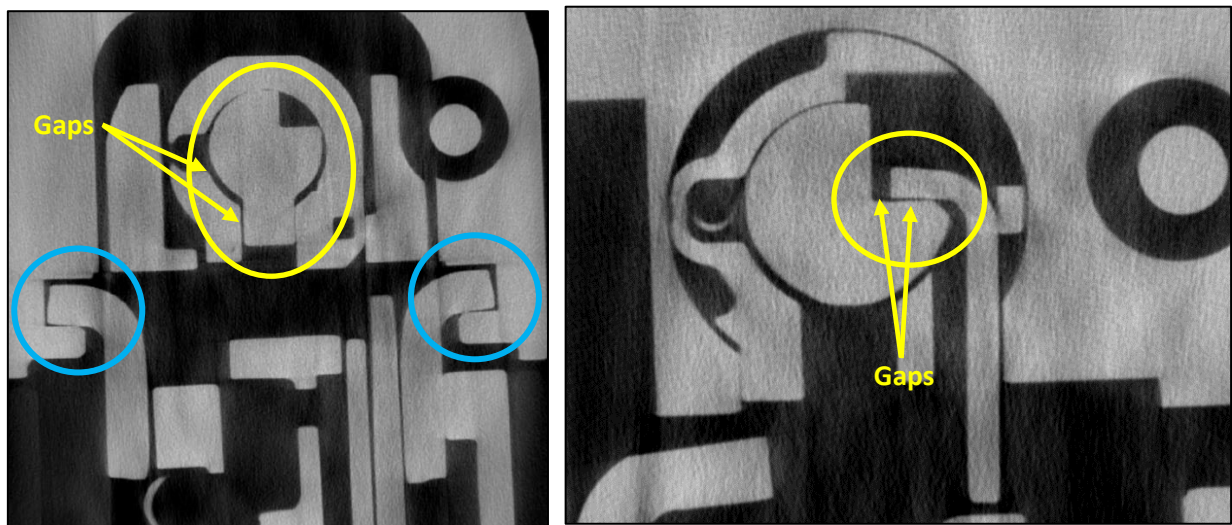
7. In looking at the rear-view CT scan slices of the striker pin relative to the housing, there are gaps within the striker housing, as shown in Figure 11 (left within yellow circle). This allows for axial rotation and movement of the striker pin within the housing each time the firearm is discharged and the slide cycles. This movement will also cause the safety lock tab that makes contact with the parallel horizontal plane of the striker body to become out of alignment, and not parallel, creating a gap. Based on the component drawings supplied by Sig Sauer, the maximum allowable angle of the striker pin to the housing is nearly 4° , however, Sig Sauer had not produced any assembly drawings that documents the specification of the complete striker assembly. The misalignment and rotation will cause minimal contact between the safety lock tab and the rear vertical stop portion of the striker, thereby reducing the contact area between the two surfaces. The misalignment would allow the striker pin to continue its forward movement when the striker foot is no longer retained by the sear, leading to an un-commanded discharge. The misalignment of the safety lock tab to the striker pin is also shown in Figure 11 (right).

Figure 11 - CT scan view from the front of striker gaps to housing (left) and safety lock tab misalignment to striker pin (right)

8. The CT images from Figure 11 (left) above also illustrate the slide assembly gaps to the grip module (circled in blue). These gaps allow the striker foot (as part of the slide assembly) to move vertically and laterally relative to the sear (in grip module) with any vertical and lateral movement, such as that experienced while the firearm is carried in a holster. The frame receiver stamping is not made to specification which contributes to the variation and fitment issues between the slide assembly and the grip module. The horizontal legs are both over 96° from the vertical leg, when the drawing specification indicates 90°. Also, the overall width between the slide tabs measured 21.6 mm, smaller than the 21.81 mm nominal specification. The CT scan is shown below (left) with the frame receiver stamping drawing image (right) in Figure 12. The bottom surface of the receiver tabs are shown as datum "Z" on the Sig Sauer drawing 1301552⁹ and all four tabs have a GD&T callout specifying flatness as 0.1 mm. Since none of the four tabs on the frame receiver stamping are perpendicular or flat relative to datum "Z", the frame receiver component does not meet the drawing specification.

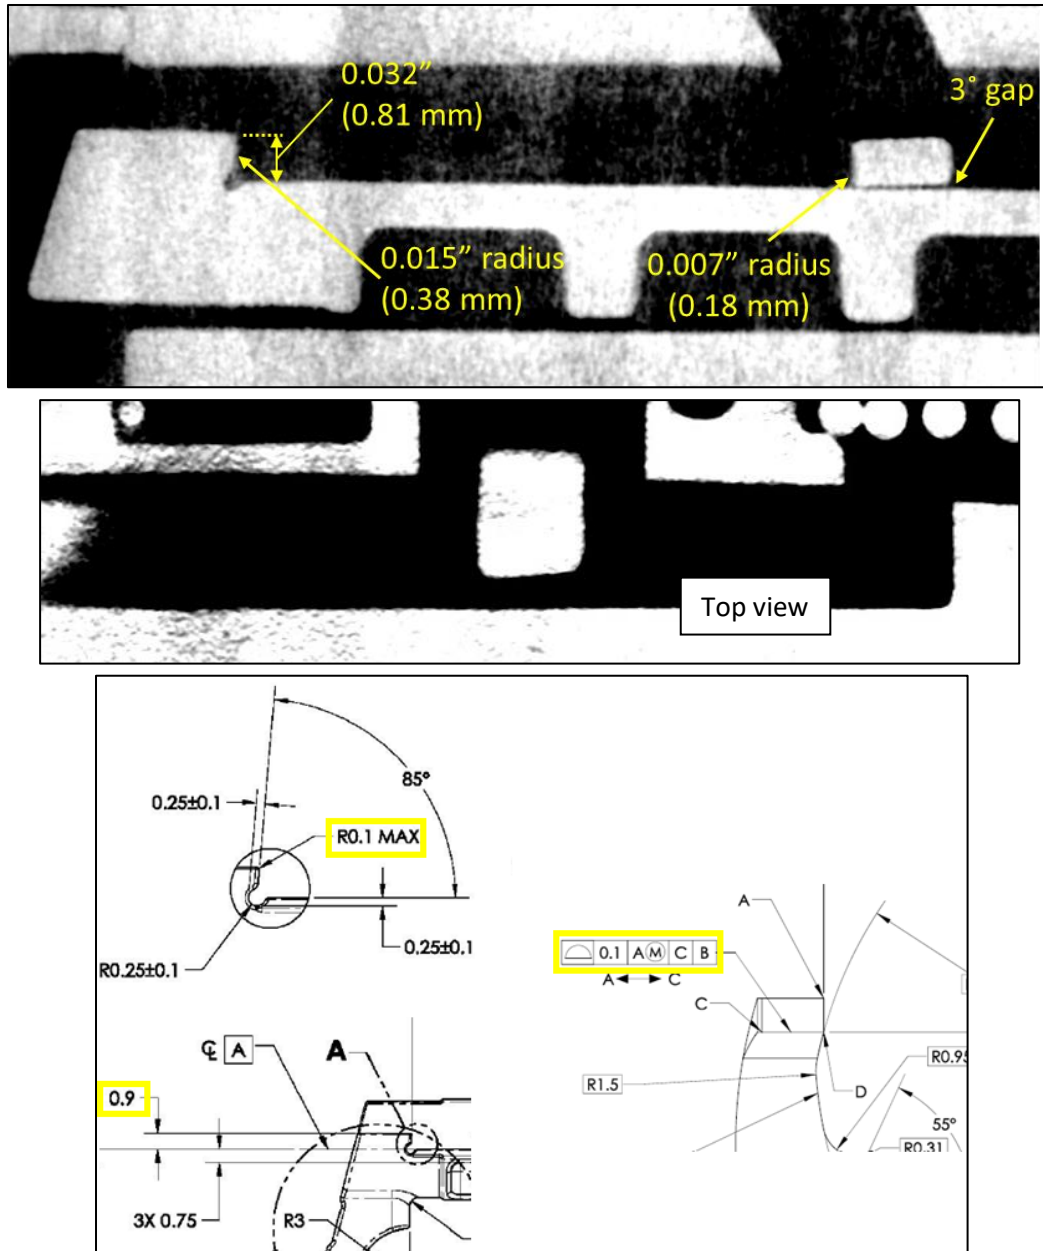
The CT scan was also used to measure and quantify the safety lock and striker stop from a side view. Figure 16 shows the CT scan measurements for the striker stop and safety lock (top and center) and the corresponding area from the Sig Sauer drawings (bottom). These images show the safety lock tab is not formed properly since the 3° gap (which measured at 0.005" or 0.127 mm) is beyond the surface profile designation on the Sig Sauer drawing¹¹ of 0.004" (0.1 mm). The striker stop has a 0.030" (0.38 mm) radius profile and is 0.032" (0.81 mm) high, compared to 0.004" (0.1 mm) and 0.035" (0.9 mm) respectively, from the Sig Sauer drawing #1302193¹², shown in Figure 16 (bottom).

Figure 16 - CT scan of striker stop and safety lock (top), top view of same parts (center), Sig Sauer drawings of the same parts (below)

Since the thickness of the safety lock is specified as 0.035" (0.9 mm), the combination of the quality issues discussed above, misalignment of the striker and safety lock, and possible contact from the safety lever, it means that less than 1 mm of displacement of the safety lock will not stop the striker from moving forward if the striker becomes displaced from the sear without a trigger pull.

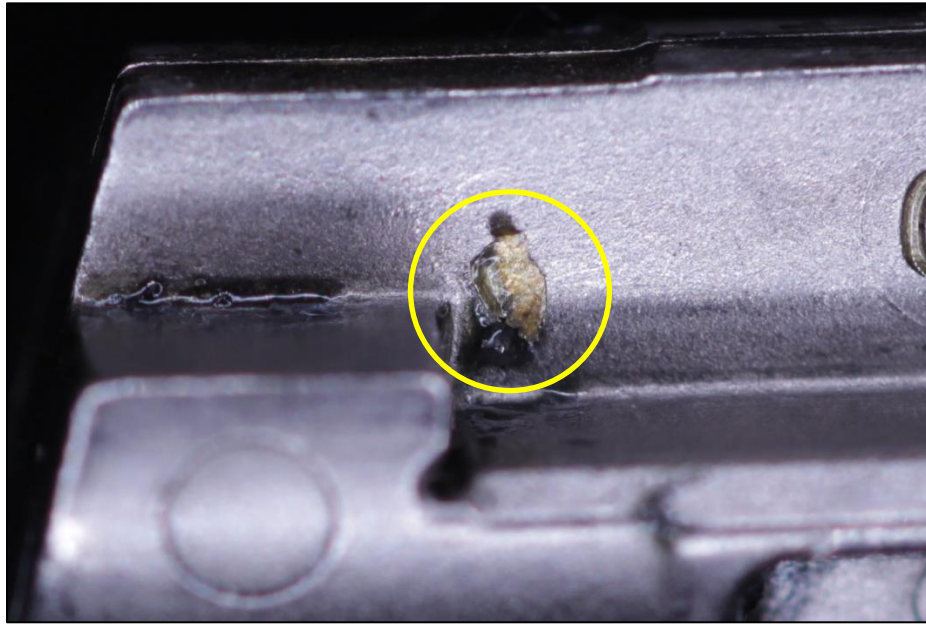
11. After the striker assembly had been disassembled, it was noticed that there was a piece of brass lodged in the corner of the striker vertical stop and the center wall area of the striker pin. In its as-found location, the safety lock tab would have made contact with it when the striker was released without a trigger pull. In this situation of having no trigger pull, the safety lock is supposed to come into contact with and stop the forward movement of the striker. Due to the components being out of specification, and the errant

brass found inside the striker assembly, the safety lock would be unable to perform its function. See Figure 17.

Figure 17 - Striker pin with brass debris at vertical stop
